perational Review
760 2	O''
Date:	10 December 2019
Date: Prepared By:	10 December 2019 George Massingham, Lead Advisor Leadership
Prepared By:	George Massingham, Lead Advisor Leadership
Prepared By:	George Massingham, Lead Advisor Leadership

EXECUTIVE SUMMARY

- 1. This report outlines the findings of the operational review into the incident which occurred at CMP Engineering Workshop on 29 October 2019.
- 2. Tāne were working in the Engineering Workshop where they are required to construct and refurbish waste skips. As part of the quality assurance checks and to assess whether any additional work needs to be carried out on the skips, they are filled with water. Any holes could indicate structural weakness, and if the skip is lifted when full of material such as concrete, this could create a significant safety risk. This is standard practice within the prison engineering setting for safety reasons. Depending on the customer and skip specifications, they are filled with water to check that they are sealed and the lifting lugs are capable of taking the load requirements. While this work was underway, five tāne were found in an intoxicated state and to have been climbing in and out of

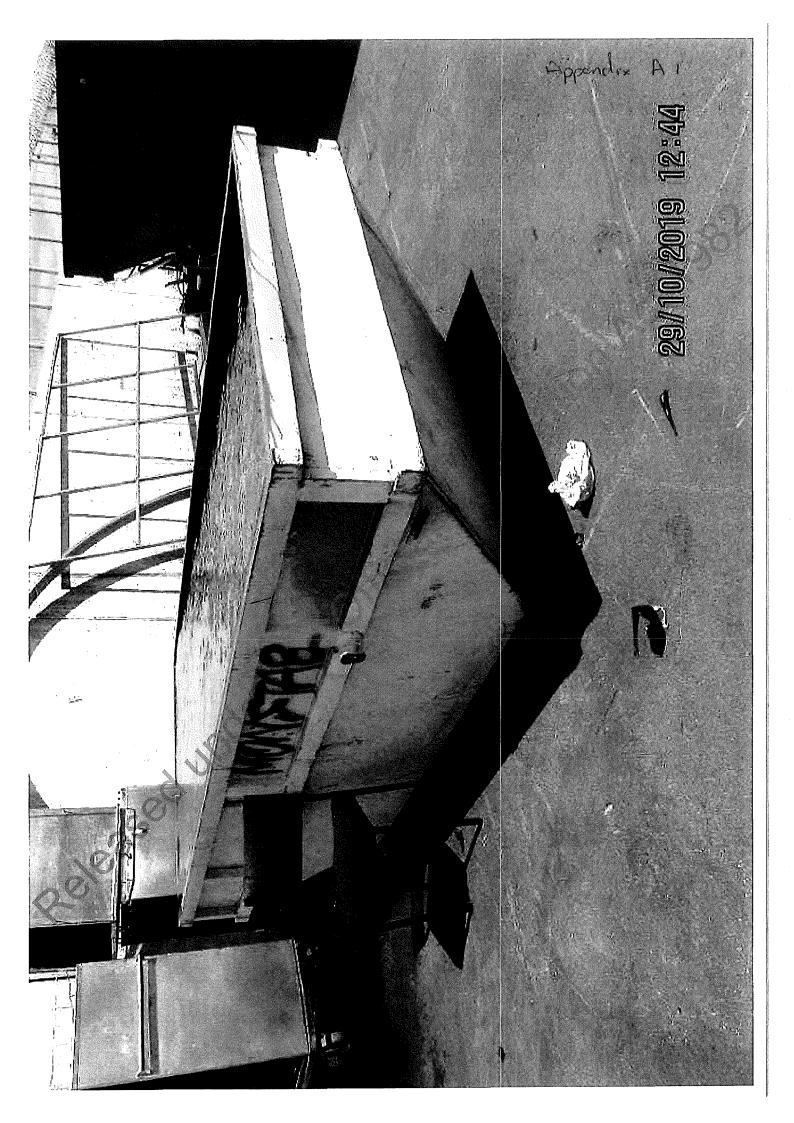
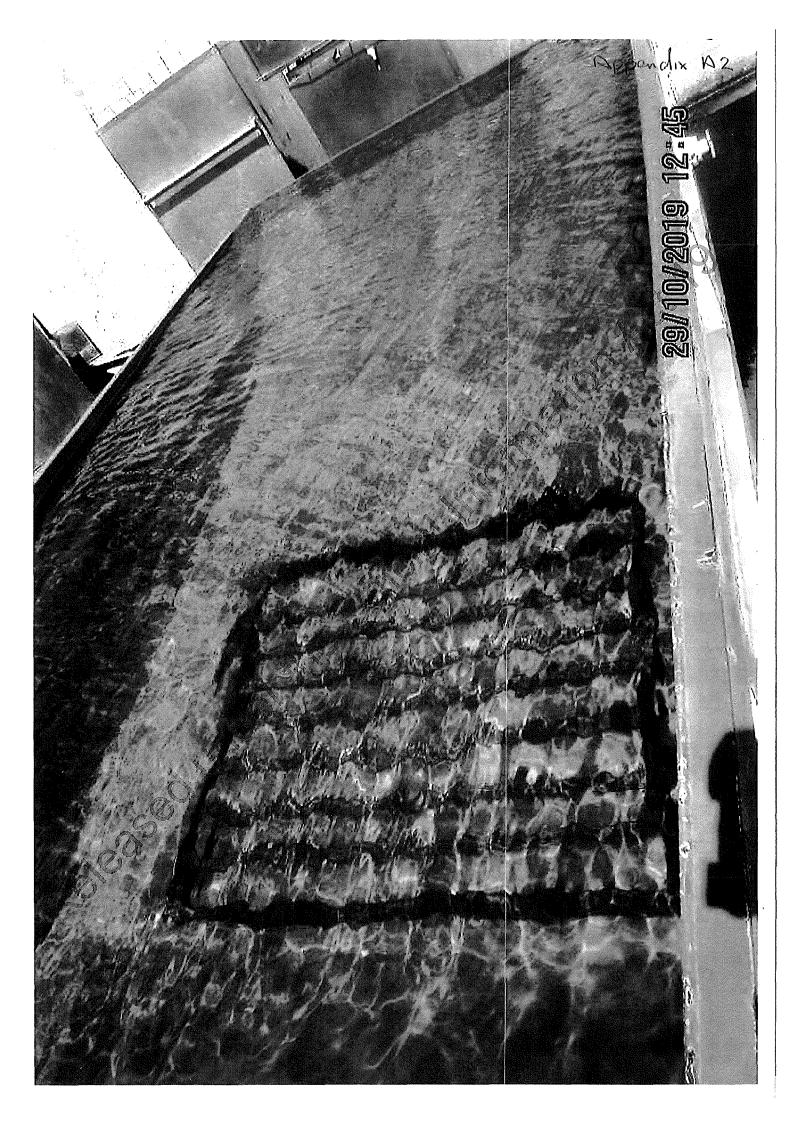
- 22. No hot debrief was held.
- 23. Information received from the staff involved and from one of the workers involved suggests they had been using a waste skip full of water to cool off (picture of skip at Appendix A) and drinking homebrew (Appendix B shows the large pot it is believed to have been served in). This was supported by the staff accounts and wet clothes seen on the footage.

- 52. The tane areas have a large amount of clutter. I viewed the area post incident and pre-clean up and again post clean up and considered it to still be too cluttered. Appendix A shows the items in the background.
